Willington Public Schools
Master Plan & Facilities Needs Assessment

For
Center School
Hall Memorial School

DRAFT REPORT

April 2024

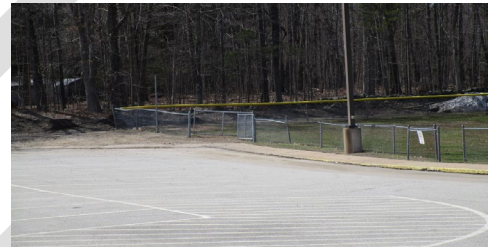
Bituminous paved driveways at the south parking lot are in fair condition. The south parking lot will need to be resurfaced in the next three to five years and signage needs to be updated. The storm drainage is inadequate, and a detention system should be provided. Any reorganization of the south lot for improvements to the site circulation requires improvements to the entire site. ADA access from the south lot to the nearest building access should be addressed so that all students have a similar travel path.

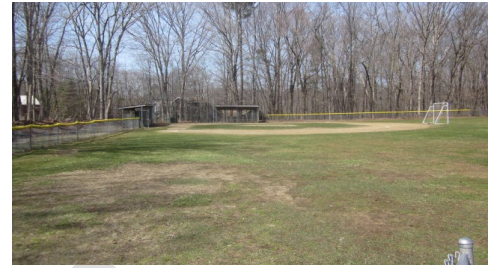
A baseball field, paved basketball area, grass play area and a playscape are provided on site. Grass and bituminous areas are in good condition and playground mulching should be replaced. Accessible paved walkways are provided from the south parking lot to each of the play areas, however an accessible route to the baseball diamond should be provided.

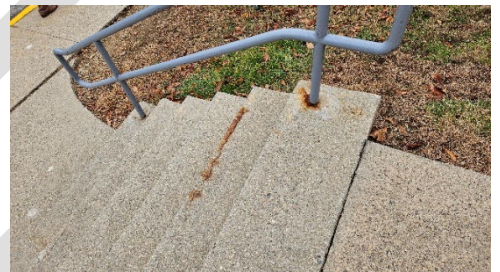
1.10 – Site Stairs

Site Stairs are in poor condition. Visible cracking is seen on concrete stairs throughout the site. The Stairs can be repaired in some locations. It is recommended that the bus loop stair and north parking stairs be replaced.

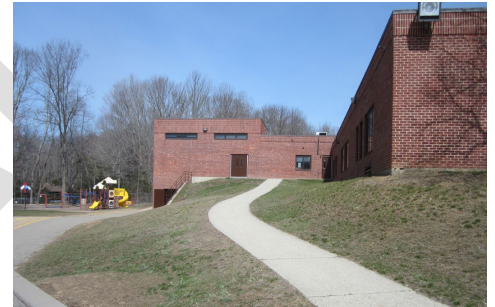
1.11 – Site Ramps

Site Ramps are in fair condition, with visible cracking seen on concrete pathways throughout site. Significant elevation changes are present throughout the site and the ramps do not meet the accessibility criteria. Additional ramps should be provided at the north and south access points to the building.

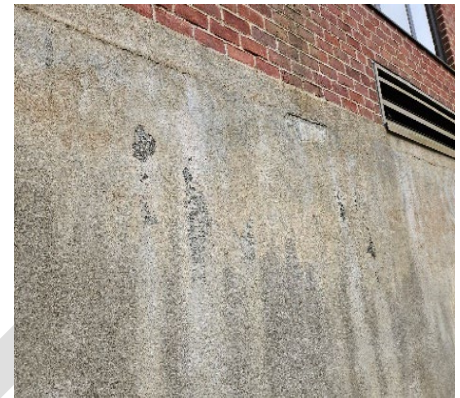
Masonry – The building exterior is primarily comprised of brick and concrete masonry units that are in fair condition. There are large areas of failing / spalling brick and sections where the masonry needs to be repointed. There are several locations where there are visible cracks that should be repointed or replaced. The sealant around the building may contain PCB's, an assumption based on the installation timeframe. The sealants around windows and penetrations should be replaced as potential Hazmat.

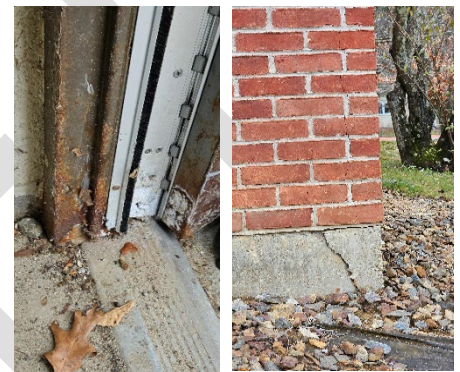
2.2 – Exterior Walls

Masonry – There are several locations where there are visible cracks that should be repointed and sections of the brick should be replaced.

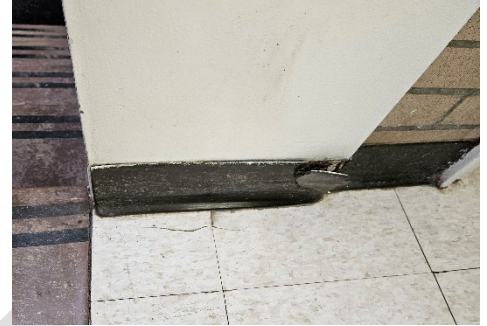
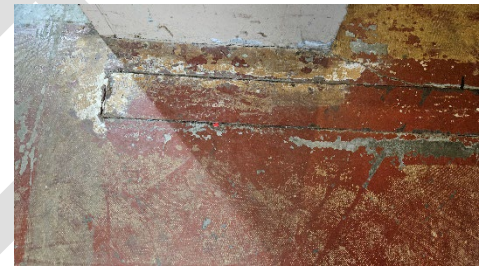
Flooring throughout the school is a mix of vinyl tile, porcelain tile, carpet tile, rubber tile, and vinyl sheet. The conditions vary throughout the school. The original building still has some of the existing floor tile which is likely asbestos floor tile. The VAT and mastic should be abated and removed from the school. There are many areas of cracked and chipped vinyl flooring that should be removed and replaced. Similarly there are rubber stair treads that are cracked or missing pieces causing a tripping hazard along the stair route.

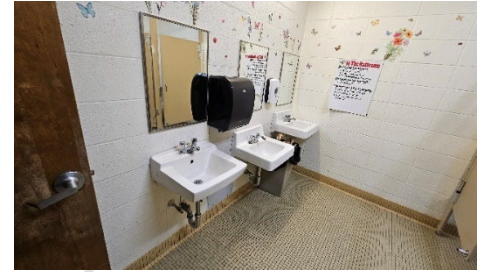
The lavatories are a mix of new and old fixtures throughout the building. Drinking fountains in some areas have been replaced recently and are in good condition. Other spaces such as the classrooms have sinks that are of original vintage and are in poor condition showing signs of leaks, countertop failure and some have been shut off completely.

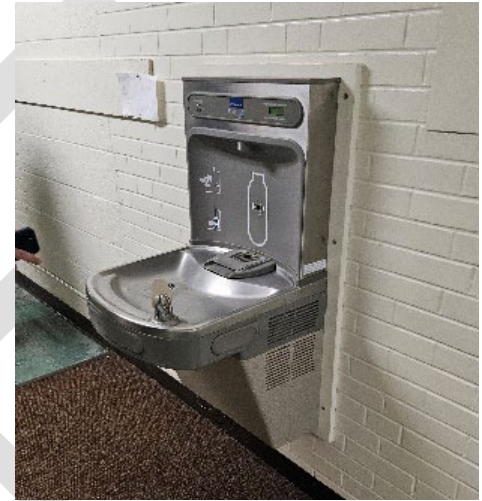
3.6 – Lavatories – Drinking Fountains

The lavatories are a mix of new and old fixtures throughout the building. Drinking fountains in some areas have been replaced recently and are in good condition. Replacement of individual units should be noted in an ongoing maintenance, repair and replacement schedule.

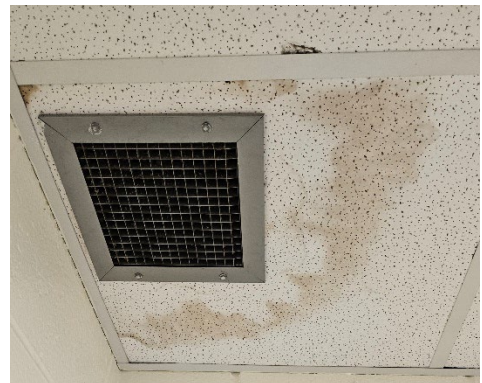
Building acoustics are heavily reliant on the acoustical ceiling tiles in the ceilings. Most walls are masonry or plaster and provide no acoustic absorption. While the acoustical ceiling tiles help absorb sound. The existing ceiling tiles are not as effective as the new tiles available today. Replacement of the ceiling tiles would help reduce the sound and reverberation within the classroom to help meet the acoustic standards required of instructional classrooms. Wall between cafeteria and art classroom is not acoustically rated and sound transfers freely between the rooms.

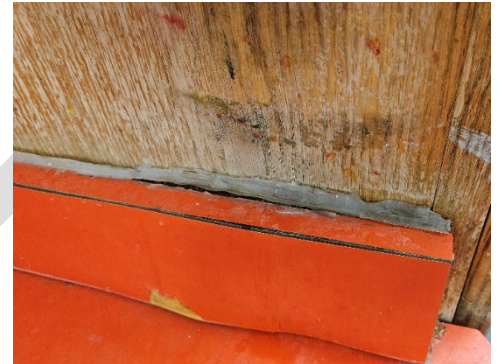
Millwork throughout the school is predominantly from the original build out of the school. The cabinets are in disrepair and have exceeded their useful life. Most millwork is damaged, broken, or ineffective for the need of today's learning environments. Classrooms with sinks in them utilized plastic laminate countertops which show water damage and delamination around the sinks. The millwork configuration does not meet ADA requirements.

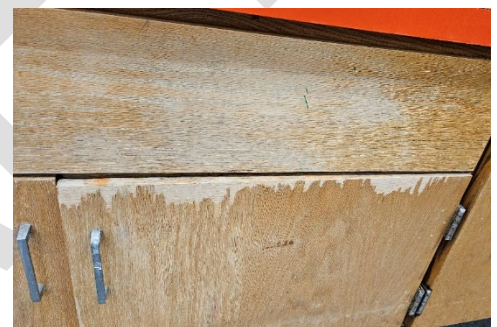
3.12 – Millwork/ Cabinets

Millwork throughout the school is predominantly from the original build out of the school. It is in disrepair and has exceeded its useful life. Most millwork is damaged, broken, or ineffective for the need of today's learning environments. Classrooms with sinks in them utilized plastic laminate countertops which show water damage and delamination around the sinks. The millwork configuration does not meet ADA standards.

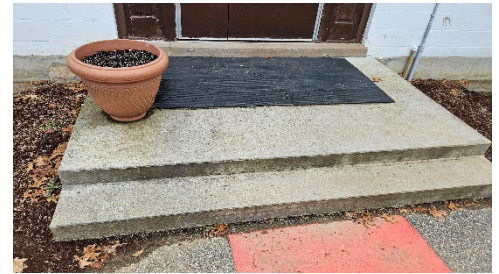
Stair treads are damaged and present a safety / egress hazard. Stairs at west side of building near gym have settled or structurally shifted causing treads to not be flat and flush further exaggerating the safety / egress issue.

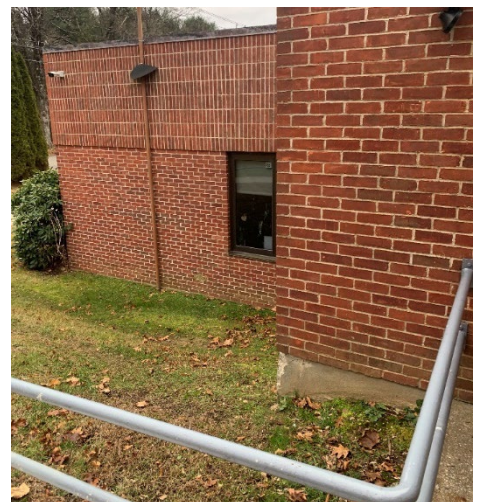
3: Partial Exterior Elevation - Spalled Corner of Concrete Foundation

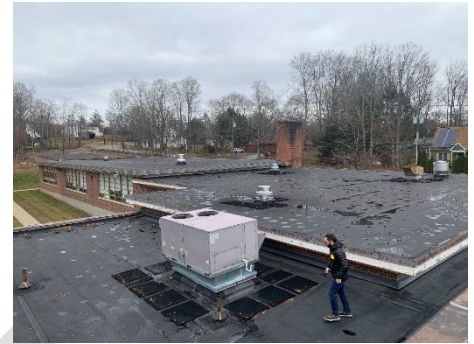
4: Partial View of Roof (Looking Northeast)

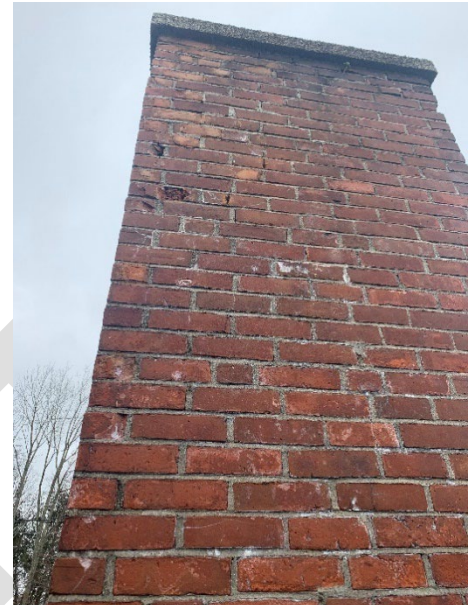
7: Close-Up of Western Chimney Elevation Above Roof (Looking East)

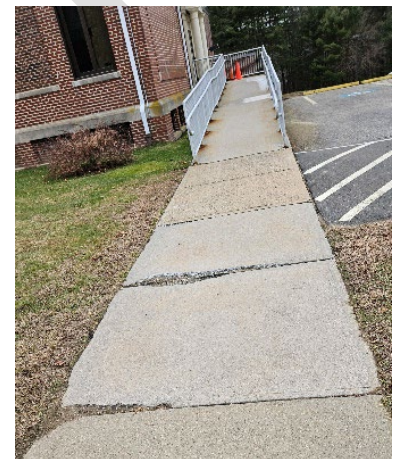
1.2 – Paving

Paving throughout the site is in fair-poor condition and should be monitored for repair and replacement in the near future. The pavement from the designated handicapped parking spaces to the upper north parking area leading to the ramp is non-compliant.

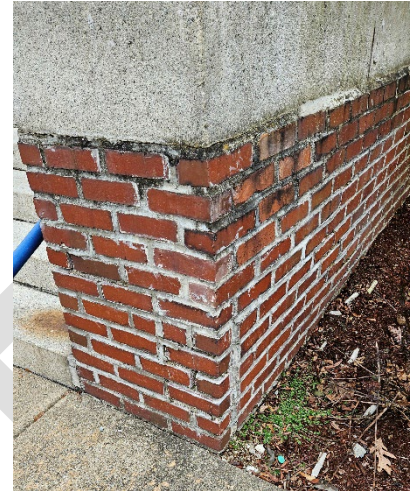
Brick – The building exterior primarily is comprised of brick and concrete masonry units that in general are in fair condition. Portions of the building masonry have been damaged throughout the years and should be repointed and/or replaced. There are also areas of spalling brick that should be reviewed and repaired. Some elevations show signs of dirt, vegetative growth (indicating potential water infiltration), and tar from roofing repairs that are recommended to be cleaned. Masonry expansion sealant joints have deteriorated over the years and are recommended to be replaced. Similarly the granite steps outside the front entry have settled and shifted. The stairs are not compliant with building codes. These should be removed and reset on proper foundation to maintain the required slope, rise and run of an egress stair.

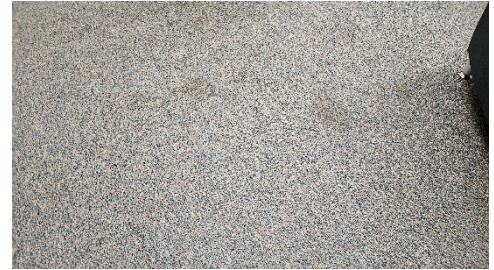
Flooring throughout the building varies with a mix of vinyl tile, carpeting, hardwood flooring, and ceramic tile. Many of the areas are showing signs of wear. Replacement is needed with the carpeted areas which are typically showing the heaviest wear. Proper entry mat materials and walk off lengths are recommended at the entry to the building. Corridors that currently have carpeting should be replaced with a lower maintenance floor finish such as linoleum tiles. Ceramic tiles within the bathroom have been damaged and are missing. These areas should be replaced.

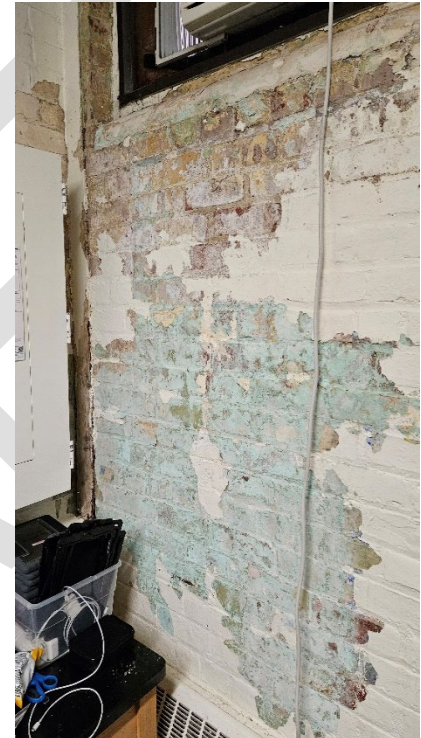
3.2 – Walls

Classroom walls are typically CMU block throughout the school with some areas also having a gypsum furred out finish. Within the original 1922 building there are also areas with plaster walls. The condition of the CMU and gypsum walls appear to be in good condition with minimal issues. The plaster walls particularly in the media center show the most wear and deterioration. There is also staining and damage shown from roof leaks over the years. These areas should be repaired and replaced.

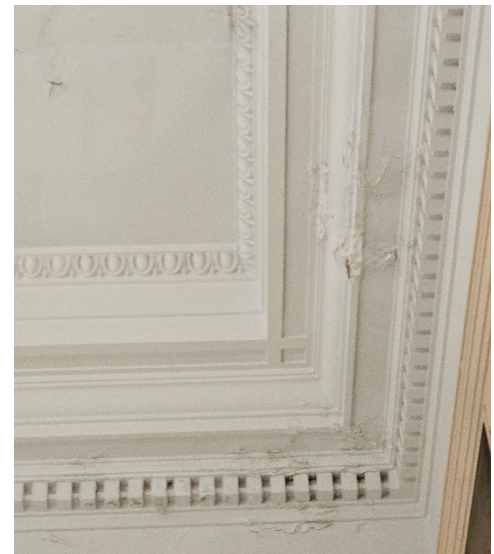
3.3 – Ceilings

Ceilings throughout the school are predominantly acoustic ceiling tiles. Portions of the original building also have the original plaster ceilings and trim. The plaster ceilings and trim have been damaged over the years and show peeling paint and water damage. These should be repaired and replaced. Similarly many of the ceiling tiles show staining from roof leaks as well as sagging and improper grid placement. The age of the ceiling tiles also point to a lower rated acoustical property that does not reach the levels of today's new ceiling tiles. It is recommended to replace damaged ceiling tiles and grids that no longer remain plum and flush. It is also recommended to look into replacement of all ceiling tiles to received a higher acoustic rating in the classrooms to better meet the acoustical ratings required. Since classroom walls and floors are all hard surfaces the ceiling tiles provide the most sound absorption of these rooms.

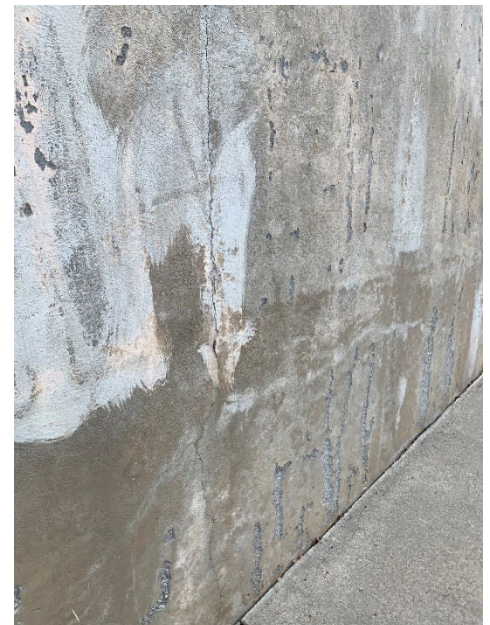
1222: Cracked Exterior Face of Existing Foundation Wall
