Willington Public Schools
Master Plan & Facilities Needs Assessment

For
Center School
Hall Memorial School

DRAFT REPORT

April 2024

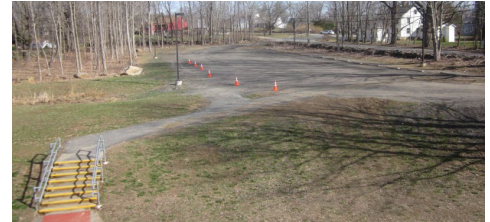
Bituminous paved driveways at the south parking lot are in fair condition. The south parking lot will need to be resurfaced in the next three to five years and signage needs to be updated. The storm drainage is inadequate, and a detention system should be provided. Any reorganization of the south lot for improvements to the site circulation requires improvements to the entire site. ADA access from the south lot to the nearest building access should be addressed so that all students have a similar travel path.

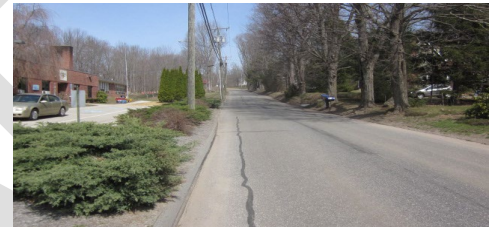
Site circulation is poor with multiple areas for student drop and pick-up. Between the north parking lot, south parking lot and accessible parking directly off Old Farms Rd there are multiple entrances and egresses into the school which is not preferred for security and creates confusion during peak and off hours. Walkways for the south parking lot are typically concrete and are in fair condition but do not meet code and ADA regulations. There is no emergency vehicle access around the building with the west side being mostly inaccessible. This creates further complications because the maintenance office and storage for the building are located on the West side making deliveries to the school difficult. There is no loading dock or designated loading area further

compromising deliveries and safety. The overall site circulation and accessibility plan should be reimagined to meet the intent of the codes.

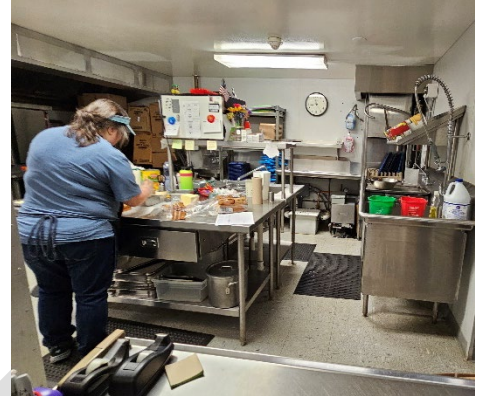
The kitchen is undersized by today's standards and by the number of students it serves. The servery line as well as refrigeration storage is brought out into the cafeteria space which further reduces the usable space within the cafeteria to house students. There is also no dedicated bathroom or changing facility for the kitchen staff. The size of the kitchen and equipment impact the quality food service program. The kitchen does not meet ADA requirements and

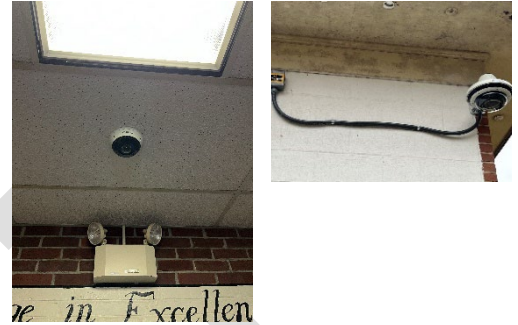
The main entrance to the building contains a video entry station with integral card reader. The main entrance to the Center School utilizes a video and audio intercom interface (AIPhone) that allows communication between the Main Office visitors entering into the building. The video image appears on a dedicated camera screen and phone at the reception desk. The inside set of vestibule doors are not secured once an individual enters, allowing anyone to go throughout the school without checking in at the main office. Additionally, there is no transaction window between the main office and the vestibule, which is typical for a secure vestibule that meets school security and safety standards. The existing AIPhone system is in good condition. An intrusion detection system for the building could not be verified. A secure vestibule can be developed by moving the inside wall of the vestibule, installing new doors and security hardware and a secure transaction window. A door from the vestibule into the main office will also be added.

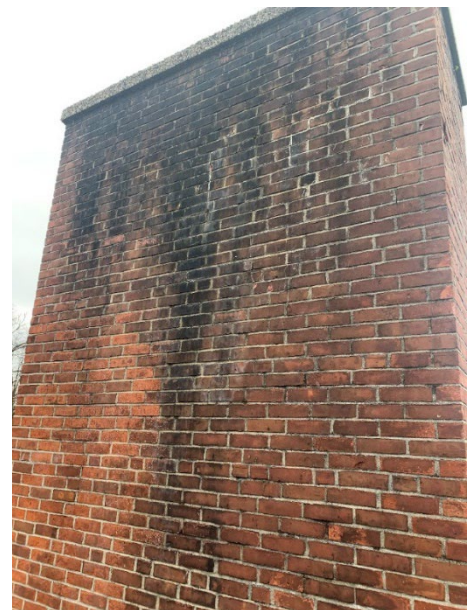
Masonry – The masonry at the chimney is in poor condition and should be addressed immediately.

6: Close-Up of Southern Chimney Elevation Roof (Looking North)

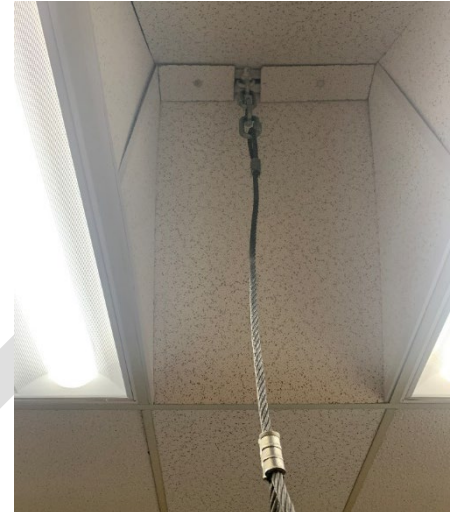
11: Suspended Wire from Existing Roof Framing

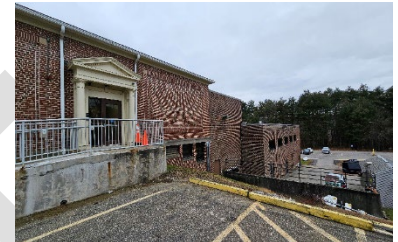
Available parking accommodates 62 vehicles, with two handicap accessible spaces available. There is an overflow parking to the east of the building with approximately 50 spaces. These parking spaces are in poor - fair condition. The overflow lot has become a regularly used lot and is used more frequently than the Western lot located behind the school due to its proximity to the main entrance. Despite a designated crosswalk and flashing lights, the traffic and site lines on Route 32 does present a problem for anyone who is crossing RT-32. More parking and Accessible van loading zones should be provided on the school site.

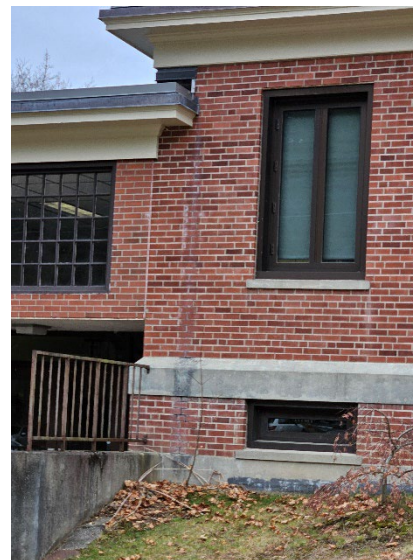
The Board of Education should commission a comprehensive Hazmat and Abatement assessment to identify all possible hazmat sources present within the building prior to proceeding with any exterior or interior building replacement work.

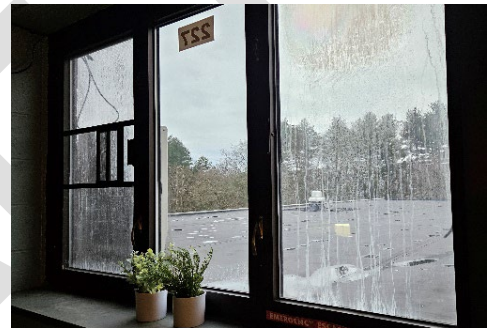
Most classroom learning spaces have access to natural light however original window openings have been infilled with brick reducing the amount of natural light into the spaces. Additionally, some spaces used for instruction have minimal at grade clearstory windows or no windows at all such as the cafeteria.

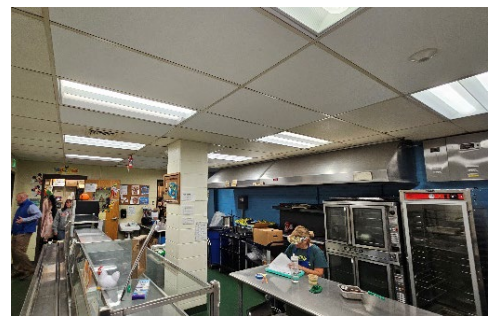
Cafeteria: The cafeteria is located in the interior of the building on the lower level. Due to its location there is no natural light into the space. The space is functional for its needs however acoustics are a concern due to the brick walls.

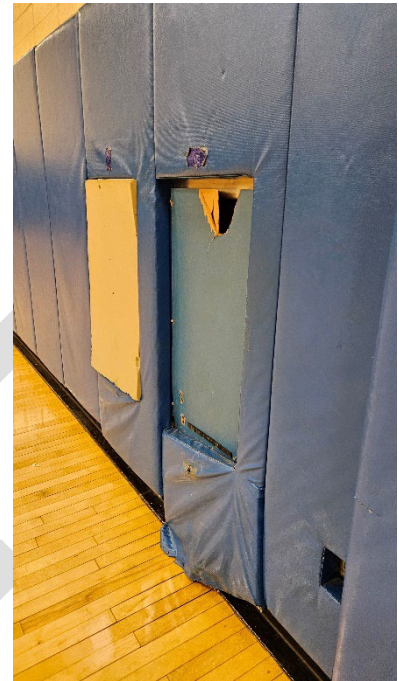
A full building analysis should be conducted for the school identifying all lead paint, asbestos and PCB containing materials as part of the hazmat plan. Some VAT has been removed due to water damage, however there are additional areas that need remediation. Hazmat must be identified in the replacement of windows, floor tiles and pipe insulation. The hazmat allowance identified in the capital improvements budget is for the abatement of these items.

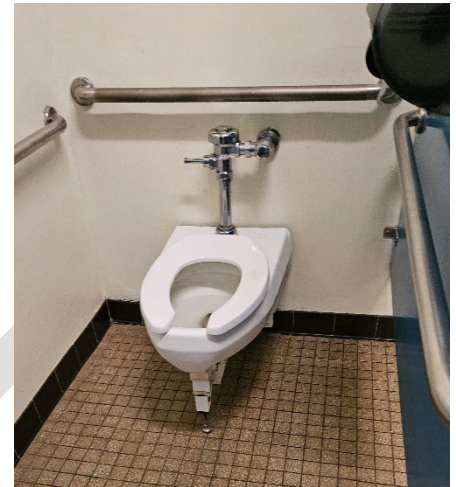
In general, the lavatories & gang bathrooms located within the school have had mixed updates throughout the existence of the school. Some bathrooms have been updated throughout the years to meet current Accessibility Codes. However, the gang bathrooms would need to be significantly reconfigured to meet accessible clearances. Certain areas have access to an accessible bathroom but others appear to be past the distance required due to the limited amount of bathrooms that are accessible.

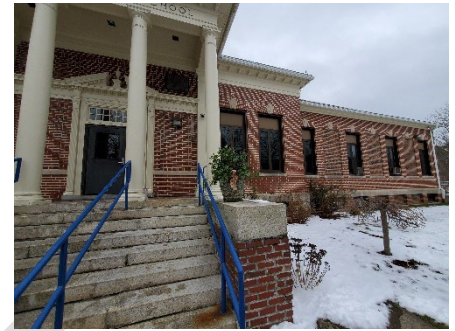
Due to the varying elevations of the building, there are many different sets of stairs throughout. Most stairs appear to be in good condition and are wide enough to accommodate accessible clearances through them however they do not incorporate areas of refuge in them. Since the building is not sprinklered areas of refuge are needed for accessible egress paths throughout the school.

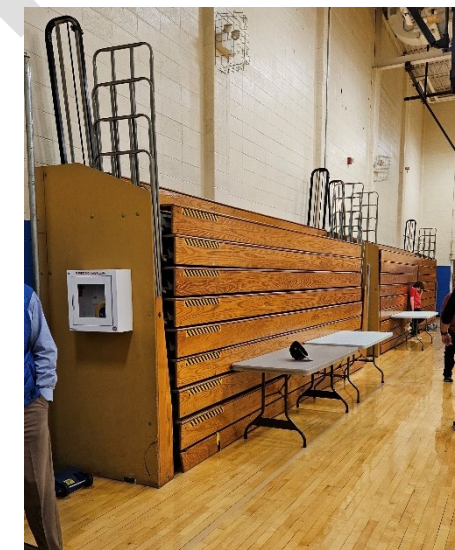
The gymnasium space is accessible through the elevator. The space in general appears to meet current requirements with the exception of the bleachers which don't appear to have accessible seating areas.

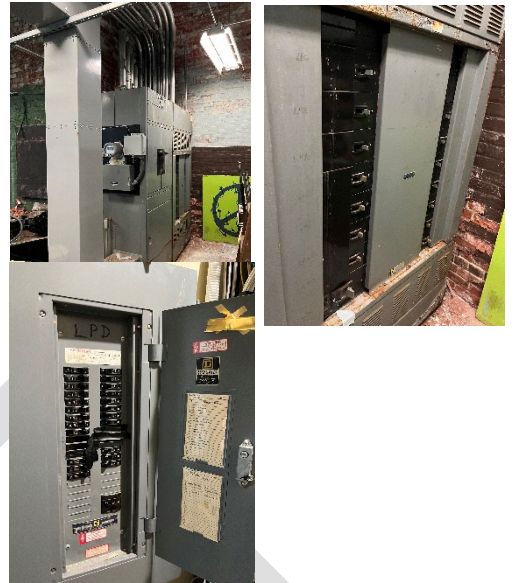
The building is equipped with a 1200A, 208/120V, 3-Phase, 4-Wire main electrical service. The main service panelboard is manufactured by Square D and is equipped with a main circuit breaker and distribution breakers. The main service equipment appears to be in fair condition.

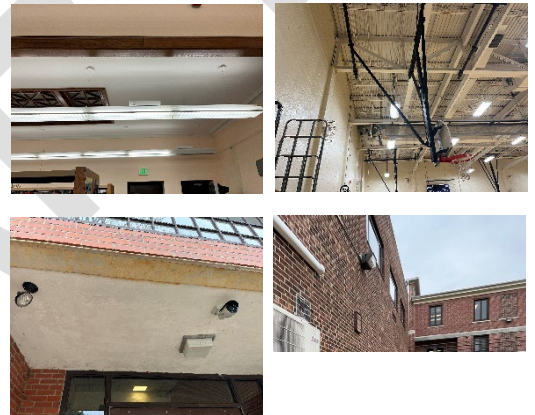
Most lighting throughout the building utilizes fluorescent lamps. Typical spaces contain recessed 2'x2' or 2'x4' troffers. Suspended high bay 1'x4' fixtures are used in the gymnasium, pendant mounted direct/indirect linear fixtures are used in the library. Lighting controls consist mostly of ceiling mounted occupancy sensors, where applicable. Lighting control device coverage appears to be inadequate in many locations.

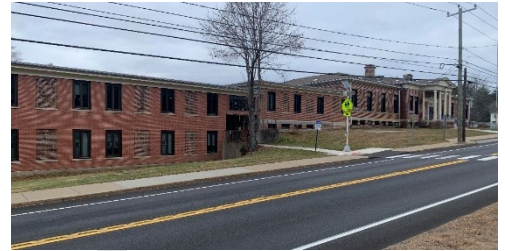
1 : Front River Road Elevation

On December 5, 2023, our office made a brief walkthrough the existing Hall Memorial School located at 111 River Road in Willington, Connecticut [see Photo No. 1]. This report provides limited cursory visual observations of the existing structure. No existing structural drawings were available for us to view, and

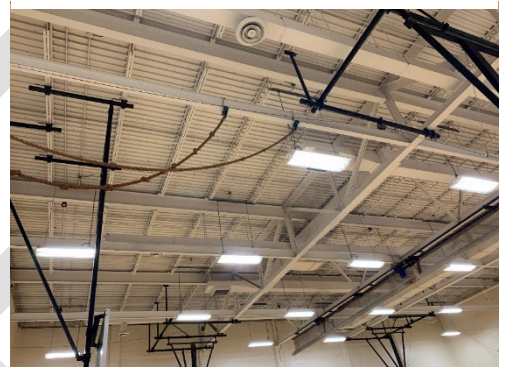
2: Underside of Gym Roof Framing

We were able to observe the underside of the gym roof framing as viewed from grade [see Photo No. 2]. The deck, open web steel joists, and steel beams appeared to be in satisfactory condition at the time of our visit. We did observe

suspended climbing ropes attached to the same beam below the roof deck. If this has not been analyzed and reviewed by an engineer, our office recommends verifying the design of the roof framing where the ropes are connected, including potential maximum simultaneous concentrated loads (including dynamic loads). Any considerations to add rooftop equipment or replace existing with heavier units on the gym roof will require a structural analysis and may require potentially costly field welded reinforcement if the capacity of the existing framing is exceeded.

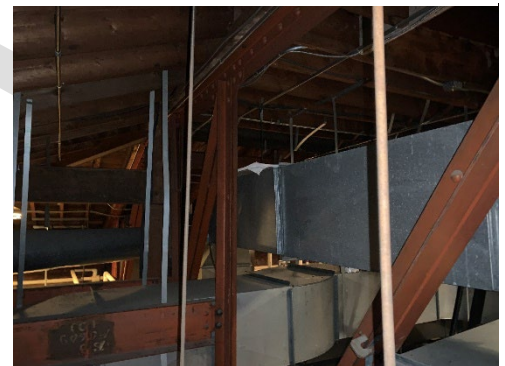
16: Partial View - Sloped Roof / Attic Framing

The original sloped roof and attic space consists of sawn lumber sloped 2x rafters and attic floor, all supported on a full depth steel roof truss system [see Photo No. 3 and Photo No. 4]. Our observations were very limited. At the time of our visit we did not see any obvious signs of structural deficiencies. If loads on or suspended below this framing are to be changed/increased, a more detailed structural review should be considered (time consuming field verifications and analysis would likely be required for any significant new loads).

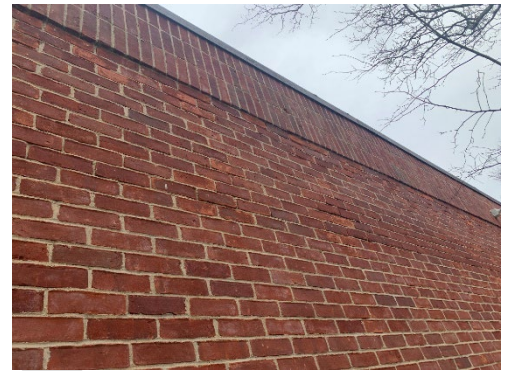
5: Partial Exterior Elevation View of Brick Masonry Veneer

observations. It appeared there was some repointing and/or brick infill at some time [see Photo No. 5]. However, updated repointing and periodic monitoring and maintenance is recommended.

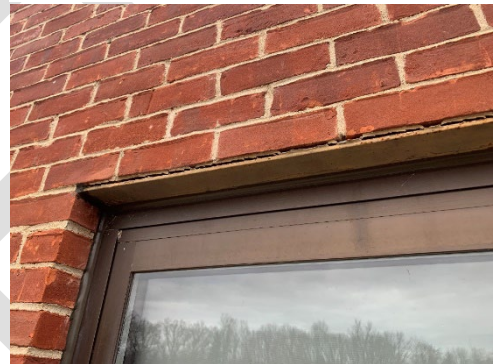
18: Close-Up of a Lintel Over an Exterior Window

The condition of existing exterior steel lintels over door and window openings varied. In some cases the flexible joint between the lintel and underside of brick veneer was cracked and in poor condition [see Photo No. 6]. Our office recommends repairing all of the joints (water infiltration during freeze-thaw cycles can cause damage from expansion and contraction).

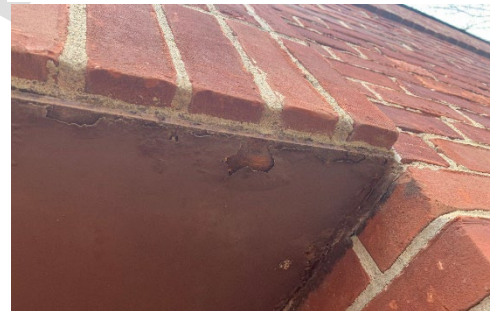
19: Close-Up View of Underside of an Exterior Lintel

In another location we noticed the paint coating on the steel lintels peeling and oxidizing [see Photo No. 7]. This corrosion of the structural steel is an electrochemical process that requires simultaneous presence of moisture and oxygen. If not addressed properly the structural integrity of the steel can be compromised. Our office would recommend removing all loose mill scale, loose rust, loose paint, and other loose detrimental foreign matter by chipping, scraping, sanding, and wire brushing. All exposed steel should be recoated with an approved exterior grade zinc-rich coating system.

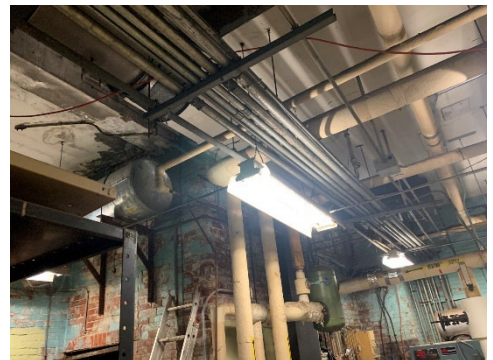
8: Underside of Floor Framing Above Boiler Room

We briefly entered the school's existing lower level boiler room. The roof structure (floor above) appeared to be reinforced cast-in-place concrete with concrete beams or possibly concrete encased structural steel framing [see Photo No. 8]. The condition of the underside of concrete should be inspected. Any potential loose or spalled concrete should be repaired with an approved compatible repair mortar.

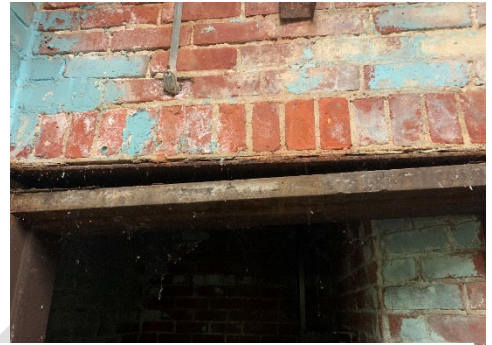
20: Door Opening Lintel in Boiler Room

We observed some questionable structural elements. The header and steel lintel into a masonry shaft appeared to be showing signs of deterioration/oxidation [see Photo No. 9].

This condition and other similar lintels should be reviewed and repaired as required.

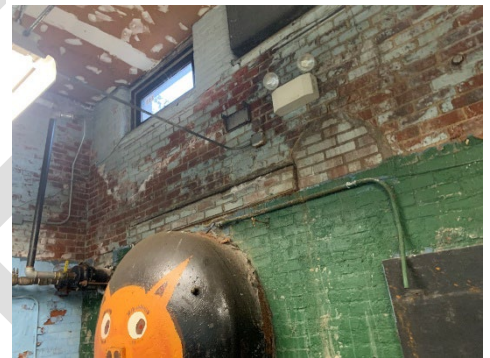
211: Interior Face of Interior Boiler Room Exterior Wall

There were also some spalled mortar joints and random cracks visible along the interior surface of the boiler room and shaft walls [see Photo No. 10 and Photo No. 11].

The plumbness and condition of all brick masonry should be reviewed. Deficiencies should be noted and repaired accordingly.
